SUNFLOWER TURBOALTERNATOR CSU I-3A

4329-HOUR-TEST SUMMARY REPORT

Prepared under Contract No. NAS 5-462 by
THOMPSON RAMO WOOLDRIDGE, INC.
Cleveland, Ohio
for .

NATIONAL AERONAUTICS AND SPACE ADMINISTRATION • WASHINGTON, D. C. • APRIL 1965

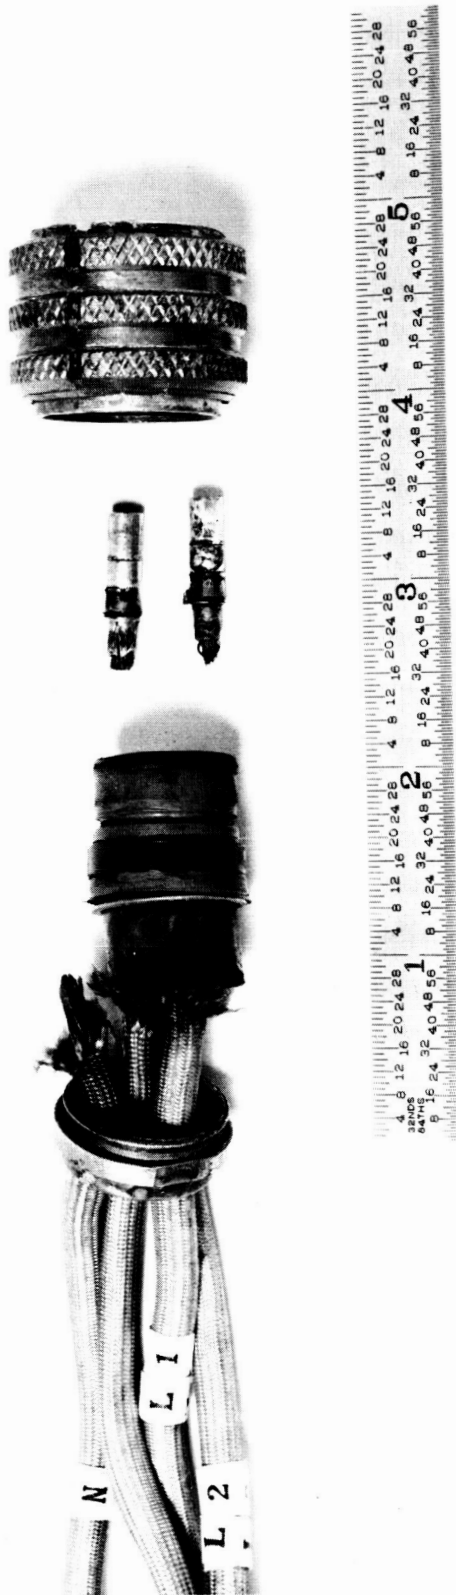
FIGURE 33

SUNFLOWER COMPONENT TEST RIG ELECTRICAL CONNECTOR AFTER 6741 HOURS OPERATION
